Albany Effluent Irrigation Tree Farm Triennial Report 2007

**Great Southern Region
Customer Services Division**

**Albany Effluent Irrigation Tree farm
Triennial Report 2007**

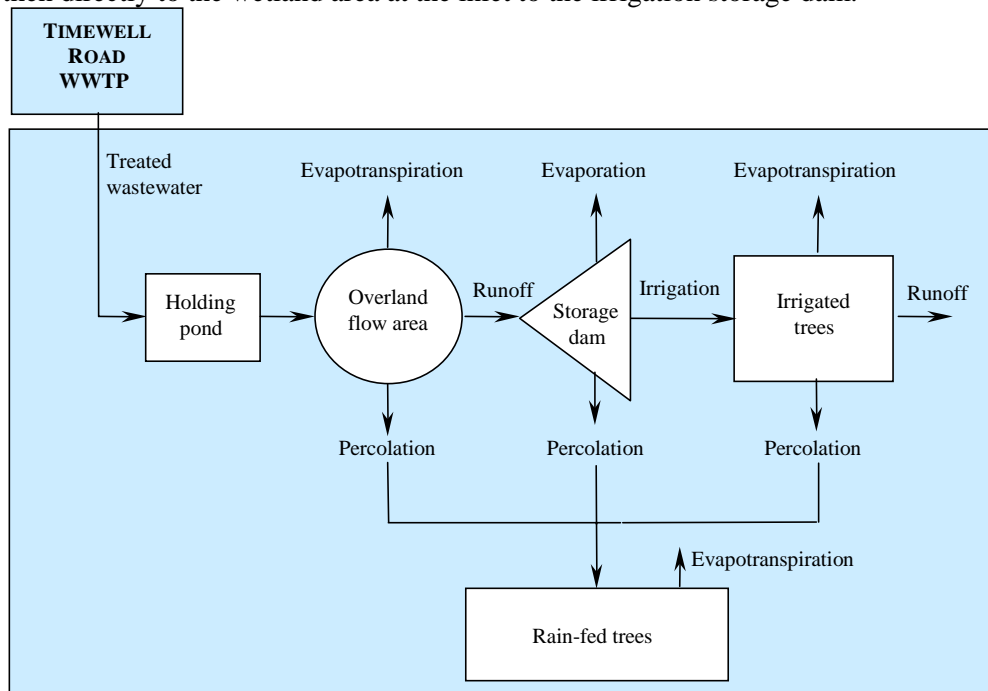
Figure 2 Land treatment flow diagram

A schematic of the tree farm process is shown in Figure 2 below. Treated wastewater is pumped from Timewell Road directly into two holding ponds at Gunn Road. These ponds supply a distribution pump station that delivers the wastewater to overland flow grass bays. There are 34 individual grass bays that give a total overland flow area of 14 hectares. The 34 bays are divided into 2 groups that are flood irrigated, each on a 6 hours ON-6 hours OFF cycle. Because the inflow to the ponds can exceed the hydraulic capacity of the grass bays, a bypass is provided that diverts excess flows to additional grass bays and then directly to the wetland area at the inlet to the irrigation storage dam.

The irrigation storage dam collects all surface runoff from the wetland and overland flow grass bays. The dam supplies the irrigation pump station through a floating off-take for distribution over the 283ha of irrigated blue gums. The pump station has facility for dosing of either sodium hypochlorite or hydrochloric acid for pH control however should it be needed.

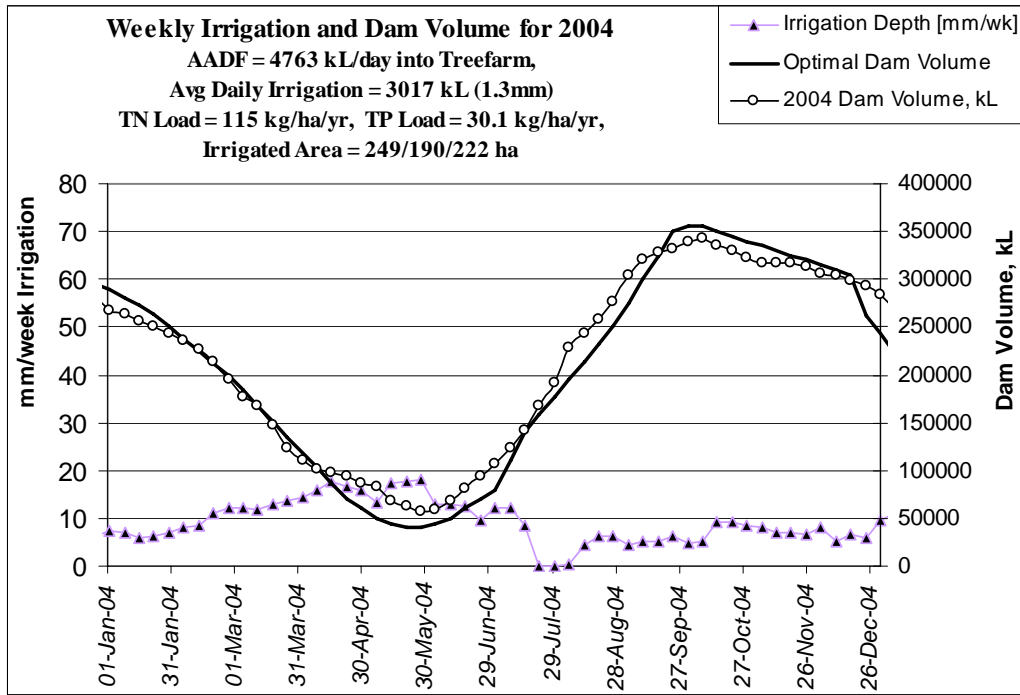
Figure 3 Dam volume and weekly irrigation summary for 2004

Figure 3 to Figure 6 below show the weekly irrigation depth and the level in the main storage dam for each of the reporting years 2004 to 2006. This data provides an overview of growth in wastewater flows and the capacity of the infrastructure at the tree farm. Average irrigation depth and the nutrient loadings are calculated from weekly data, while the 'irrigated area' is the area before, during and after the annual harvest. The annual average site inflows during 2005 and 2006 were 5284 and 5222 kL/day respectively. This reduction in inflows reflects the extreme rainfall events experienced in 2005, and the much lower total annual rainfall 2006. These inflows are approaching 90% of the design capacity for the site.

The capacity of the irrigation system and the design hydraulic capacity of the site are within the design values of 80mm/month during summer and 50mm/month during winter. The irrigation design gives an annual average daily irrigation depth of 2.2mm compared to the 2004 to 2006 average of 1.5mm.

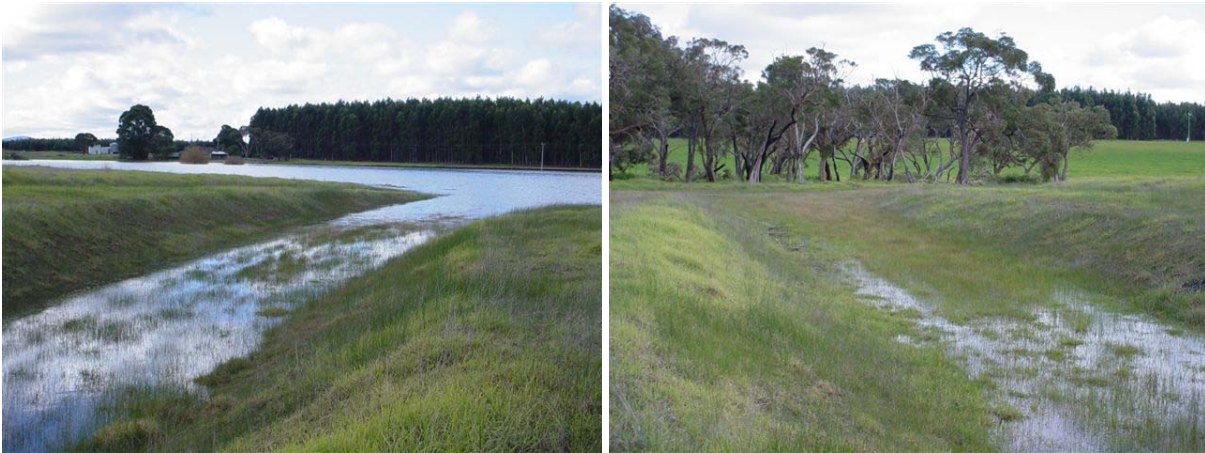
Figure 5 Main storage dam spillway during overflow July to October 2005.

Figure 5 below shows two photographs of the spillway during over flow in 2005. These photos are taken from the same location and are looking upstream and downstream respectively. They clearly show the overflow was a constant trickle rather than a storm flow. This is because overflow occurred well after the storm events that filled the dam above the irrigation capacity of the site. It is estimated that the peak overflow rate reached 1ML/day intermittently over the 16 week period, with an estimated

total overflow volume of 50ML. The over flow dissipated after leaving the spillway, and followed natural drainage channels for a short distance until no surface flow could be observed. The nutrient loadings in the overflow (1200kg TN and 175kg TP) are significant relative to the historic discharges from site, and elevated nutrient concentrations in groundwater and surface water along the overflow path is expected.

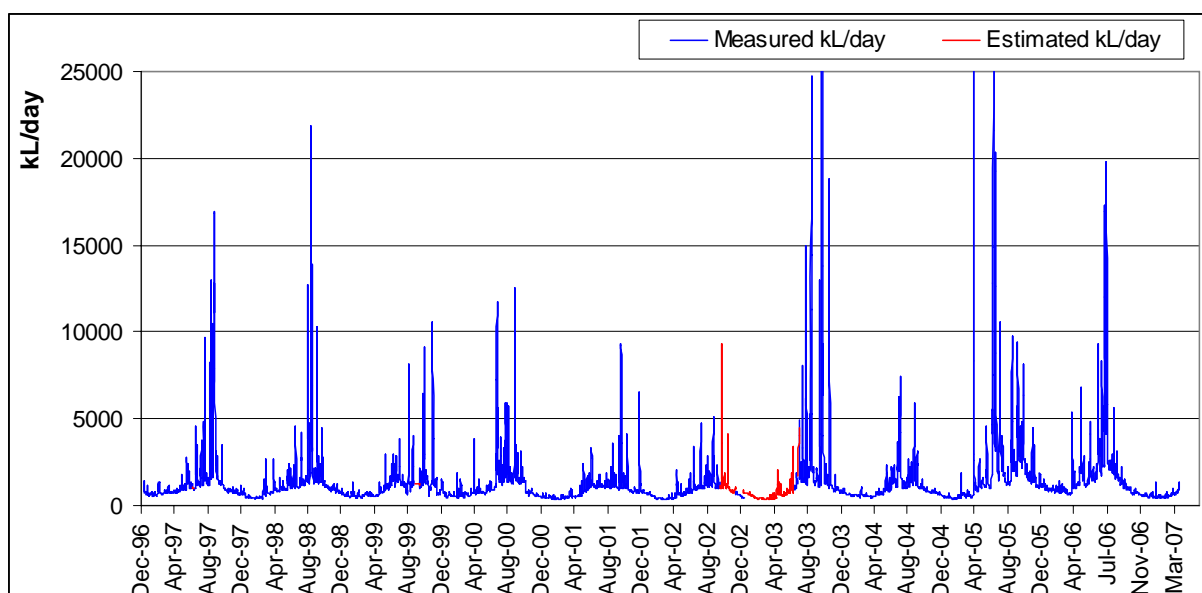
Figure 8 Streamflow at Gunn Road gauging station, 1997 to 2006

Surface discharge from the land treatment site is measured at the Gunn Road gauging station at the head of the Seven-Mile Creek. There is automatic flow logging and water quality sampling at this point. The daily discharge for the period 1997 to 2006 is shown in Figure 8 below.

Some very high storm peaks in the 2005 and 2006 discharge can be attributed to high and extreme rainfall events. Weekly rainfall in excess of 40mm was recorded on several occasions in 2005, including two consecutive weeks in April when rainfall exceeded 100mm/week. Peak rainfall in 2004 and 2006 did not exceed 50mm/week.

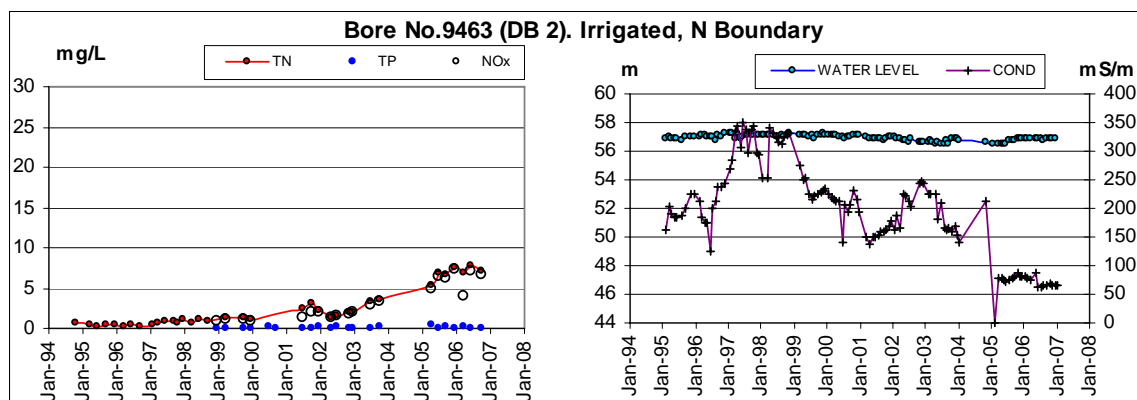
Figure 10 Bore 9463 Northern boundary – nutrients, conductivity and water level.

Bores 9462 and 9463 located on the sites northern boundary show a nominal increase in total nitrogen concentration over time. Bore 9462 is in a rainfed tree area and 9463 is in an irrigated tree area. Whilst the design of the tree farm anticipated that irrigation effects would not be seen in groundwater until more than 10 years after irrigation commenced, it is unclear why an increase would be seen in the

rained area. However, the falling conductivity in bore 9463 suggests that this is not a direct leaching of treated wastewater. Irrigation ceased to the area around 9463 between March 2004 and April 2005 follow harvest. When irrigation resumed in April 2005 this was at the nominal rate of only 30% of design flows to allow for the low leaf area. The very low water level in this bore and in the site generally is clearly shown in bore 9463 even despite the removal of trees in 2004.

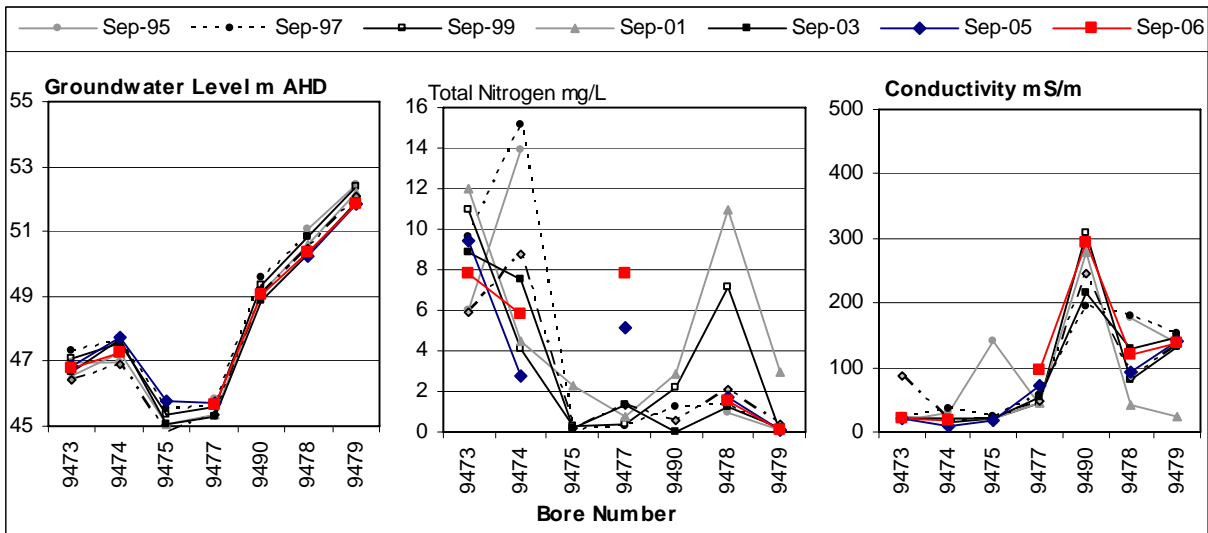
Figure 11 Cross-section of bore data along the southern boundary

Groundwater from the tree farm exits the site along the southern boundary. Figure 11 below shows variations in groundwater level, total nitrogen concentration and conductivity across the southern boundary from 1995 to 2006, though there is relative consistency between these sites over this time. There was an immediate reduction in the total nitrogen concentration along the western end of the southern boundary at the commencement of the tree farm operations, and a more recent reduction

observed at the eastern end. The 2005 and 2006 data however show increases in nitrogen in bore 9477 which is immediately adjacent the Gunn Road gauging station on Seven Mile Creek. Bores up-slope and either side of 9477 (9475 to the west and 9490 to the east) were not able to be sampled during 2005 or 2006 due to very low levels of water. Despite the wet rainfall year of 2005, the water consumption of established trees in the valley and the low groundwater level at the end of 2003 have contributed to poor recovery to historically higher water levels during this reporting period.

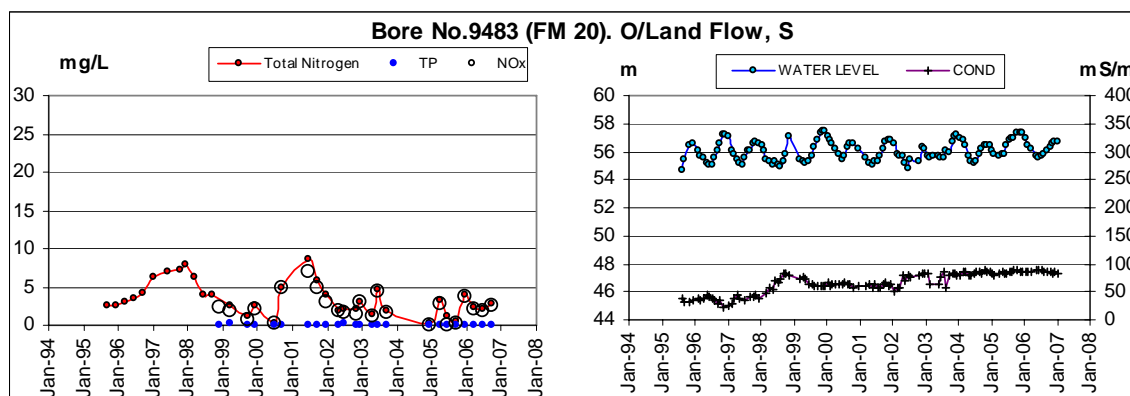
Figure 13 Bore 9483 overland flow area - nutrients, conductivity and water level.

The four bores in the over land flow area show high seasonal change in level due to the high design and operating irrigation rates and seasonal rainfall. Bore 9484 at the northern (upstream) end of the grass bays has shown a nominal decrease in level whilst all others in the grass bays have been stable. This bore is furthest from the dam and does not exhibit large seasonal variations as observed in the bores closer to the dam.

Bores 9483 (Figure 13) and 9484 are at the lower edge of the overland flow bays and show seasonal changes in level as well as typical variations in nitrogen. Bores 9485 and 9486 have high silt levels when sampled and consequently may be less reliable as indicators of nutrient impacts in the groundwater. Despite these comments, the increases in nitrate concentration below the grass bays was expected at design, and is a function of the higher nitrogen loading that has occurred in recent years.
