**Albany Effluent Irrigation Treefarm
Triennial Report 2004**

**Great Southern Region
Customer Services Division
Water Corporation**

This report covers the period 2001 to 2003. It reports on environmental monitoring at the treefarm and provides a Progress and Compliance Report against the Ministerial Conditions that were developed following the public environmental review process.

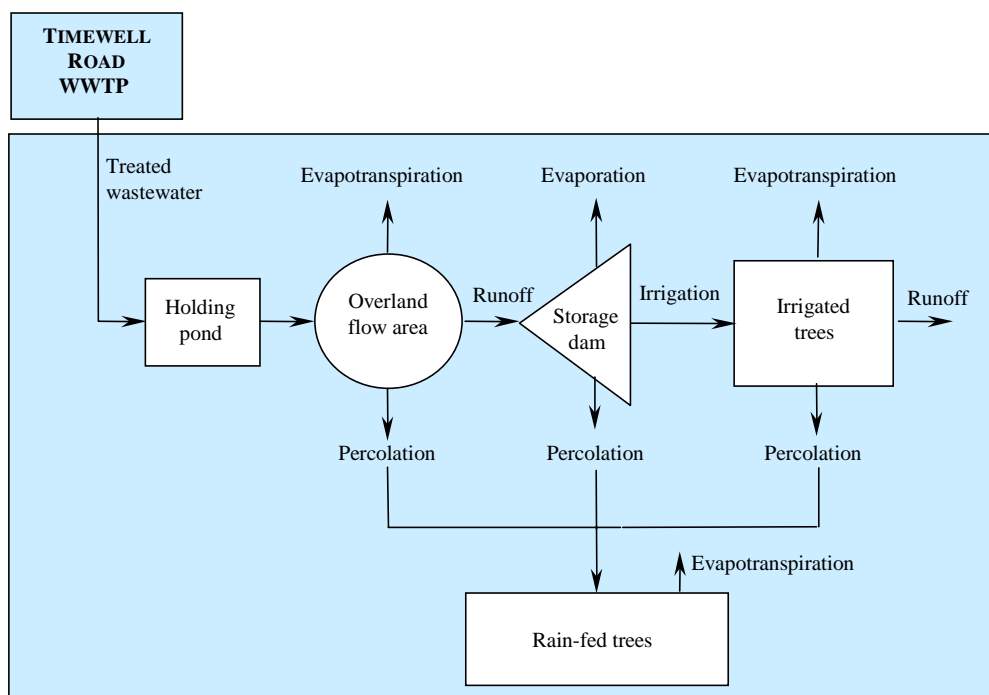
Figure 2 Land Treatment Flow Diagram

A schematic of the land treatment process is given in Figure 2 below. Treated wastewater is pumped from Timewell Road directly into two holding ponds at Gunn Road. These ponds supply a distribution pump station that delivers the wastewater to overland flow grass bays. There are 34 individual grass bays that give a total pasture area of 14 hectares. The 34 plots are divided into 2 groups that are flood irrigated each on a 6 hours ON-6 hours OFF cycle. Because the inflow rate to the ponds can exceed the capacity of the grass bays, a bypass is provided that diverts excess flows to additional grass bays and then directly to the wetland area at the inlet to the main irrigation storage dam.

The main irrigation storage dam collects all surface runoff from the wetland at the outflow from the overland flow grass bays. The dam supplies the irrigation pump station through a floating off-take for distribution over the 283ha of effluent irrigated blue gums. The pump station has facility for dosing of either sodium hypochlorite or hydrochloric acid for pH control and for chlorination to manage algae growth in the irrigation system. The system measures pH and if greater than 8.5, acid dosing is automatically initiated. Although acid has been dosed intermittently, there has been no use of sodium hypochlorite.

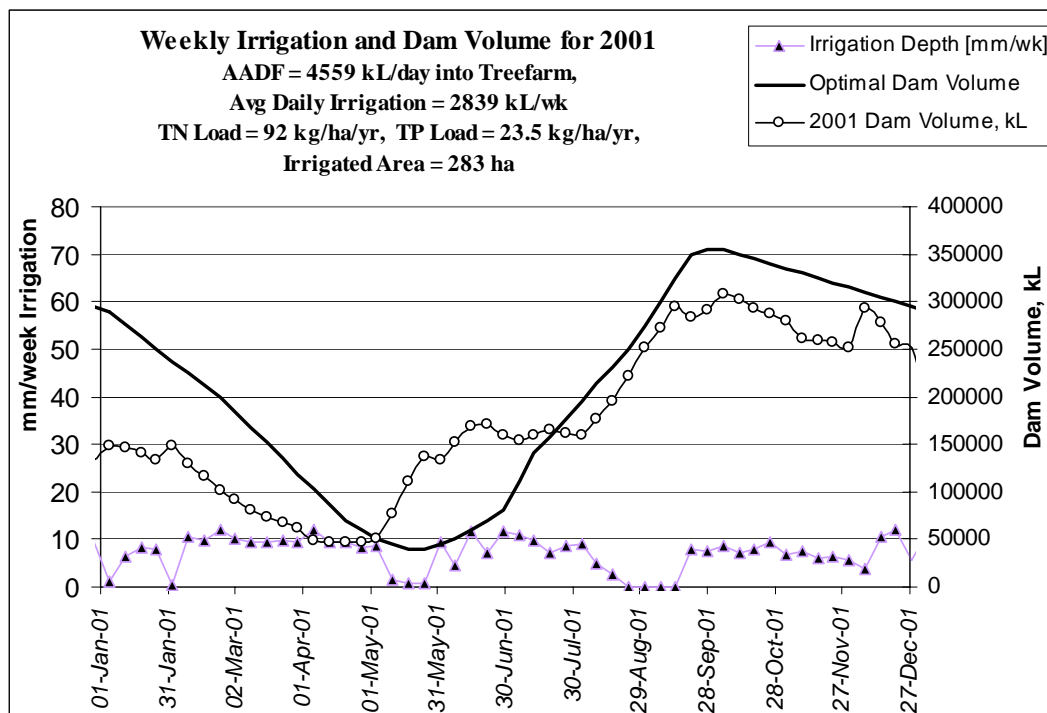
Figure 3 Dam Volume and Weekly Irrigation Summary for 2001

Figure 3 to Figure 5 below show the weekly irrigation depth and the level in the main storage dam for each of the reporting years 2001 to 2003. This data provides an overview of growth in wastewater flows and the capacity of the infrastructure at the treefarm. The average inflow during 2001 (Figure 3) was 4559 kL/day. This is about 75% of the design capacity for the site. The inflow and irrigation volumes presented here for 2002 are different to those presented in the annual report previously submitted due to calibration of the meters and subsequent correction of data in 2002. The capacity of the irrigation system and the design hydraulic capacity of the site are still well within the design values of 80mm/month during summer and 50mm/month during winter.

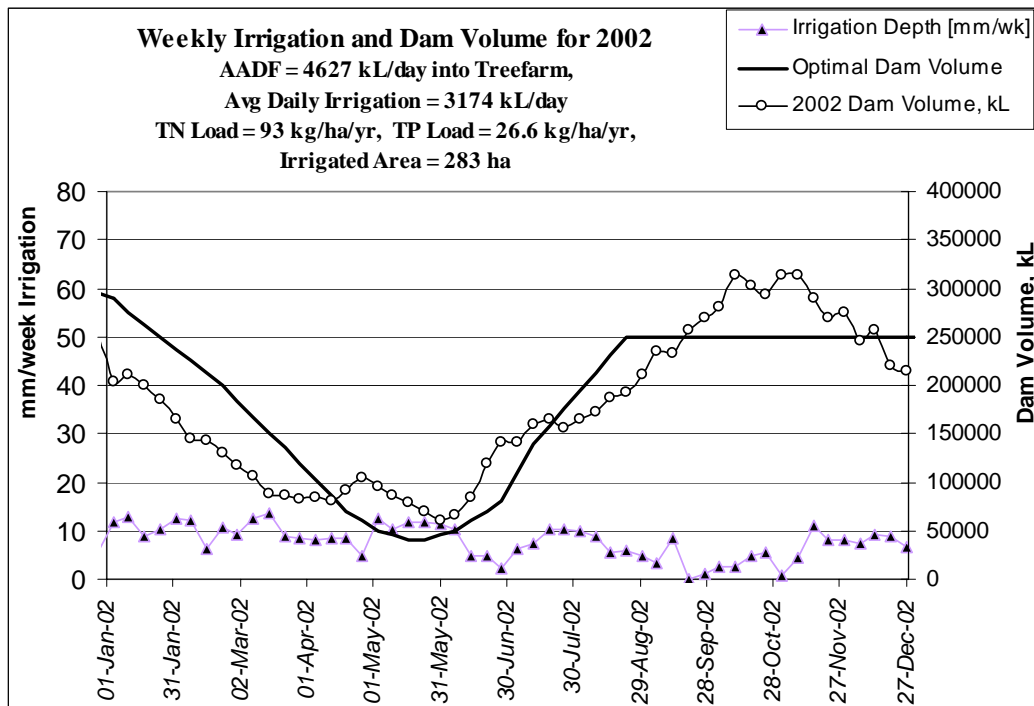
Figure 4 Dam Volume and Weekly Irrigation Summary for 2002

the optimal dam level was altered for the 2002 year (Figure 4). This allowed an increased irrigation rate to be maintained during a period of reduced winter inflow volumes.

Total irrigation in 2002 was very similar to that in 2003, despite an increase in the flow volumes delivered to the treefarm. However, the nitrogen application rate increased from 93kg/ha/yr in 2002 to 104kg/ha/yr in 2003. This increase is due to the reduced irrigation area (lower by 11%) from March 2003 when the first harvest occurred. The phosphorus application rate was constant over these years at 27kg/ha/yr due to lower phosphorus loads (lower by 10%) received at the Timewell Rd WWTP in 2003. The nitrogen concentration in the treated effluent received at the treefarm also improved, but not to the same degree (lower by 7%) so the improved quality could not fully offset the reduced irrigation area.

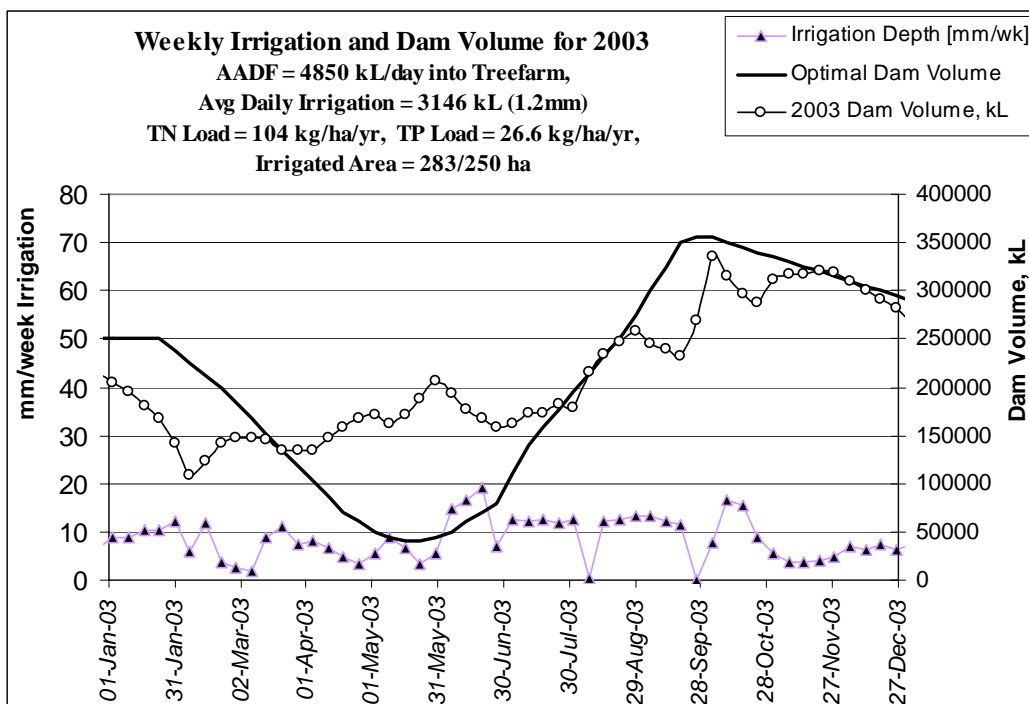
Figure 5 Dam Volume and Weekly Irrigation Summary for 2003

From mid October 2003 an algebraic irrigation model has been used to set the weekly irrigation rate. The impact of this model is shown in Figure 5 as the observed dam level tracks immediately back to the optimal dam level curve. The model was implemented as flows have increased sufficiently to warrant its use and the nitrogen load in the irrigation effluent requires more regular monitoring. Use of the model is expected to reduce variability in weekly irrigation rates as it accounts for rainfall and other variables that require consideration.

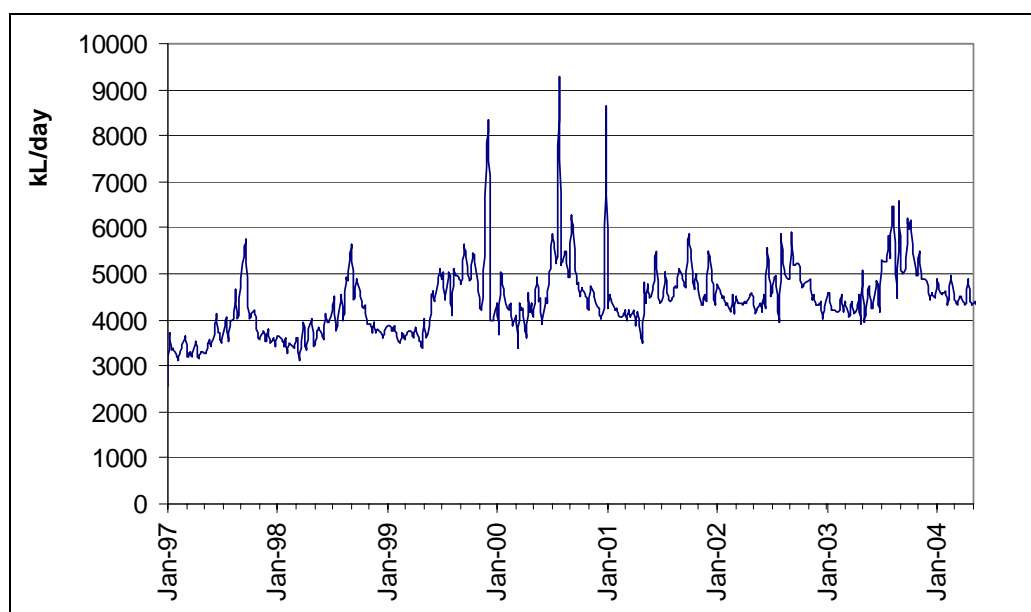
Figure 6 Daily inflow to the Albany tree farm, 1997 to 2003

An extreme rainfall over the period 29 September to 01 October 2003 resulted in overflow to Five-Mile Creek. This is not reflected in the discharge data (Figure 6) due to problems with the pressure main restricting the peak flow rate. The pressure main from the Timewell Road WWTP to the treefarm has since been scoured of accumulated sediment to reduce the head losses and increase the pumping flow rate.

The average inflow to the tree farm during 2003 was 4.85 ML/day, representing an annual growth of about 3% per annum from 2001. This compares favourably to the licensed hydraulic capacity of 5.5ML/day for the WWTP and 6ML/day for the treefarm.

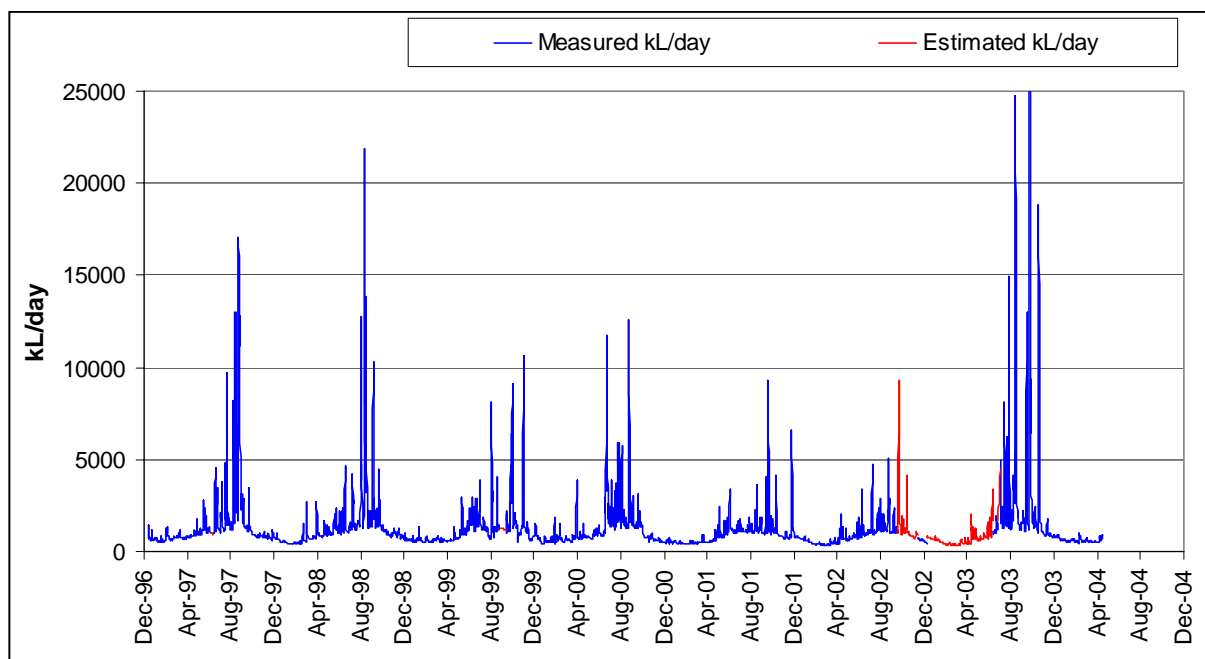
Figure 7 Streamflow at Gunn Road gauging station, 1997 to 2003

Some very high storm peaks in the 2003 discharge can be attributed to high and extreme rainfall events. Weekly rainfall in excess of 45mm was recorded on five occasions during August, September and October 2003. The largest recorded weekly rainfall of 73mm occurred during October 2003.

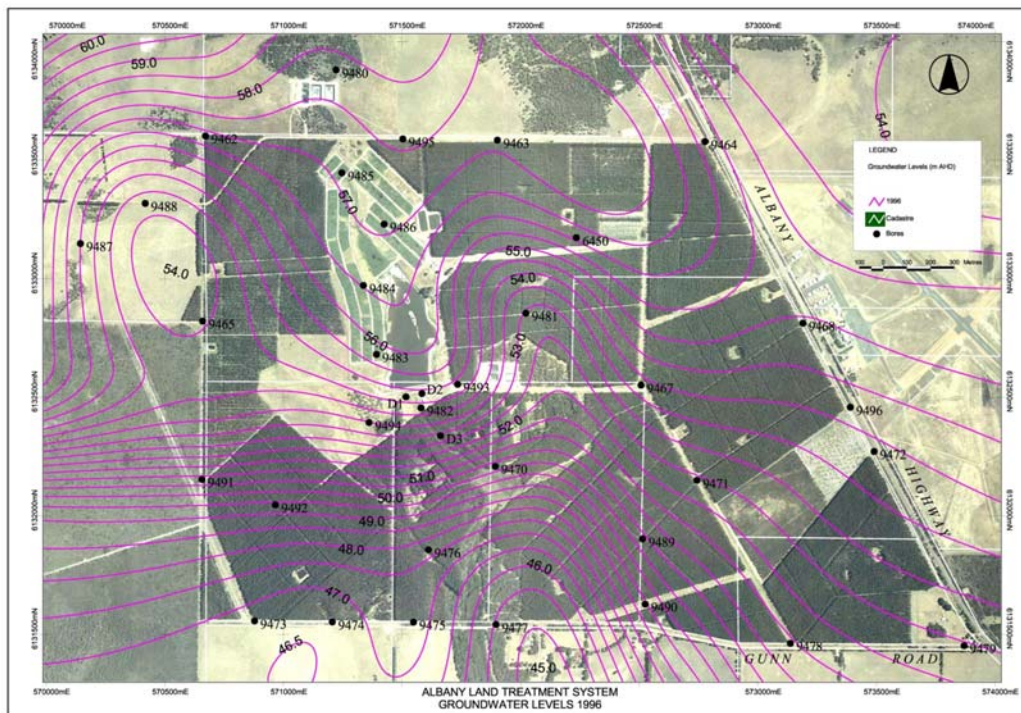
Figure 9 Groundwater Contours in March 1996

CYMOD Systems Pty Ltd has undertaken an independent analysis of the groundwater levels at the treefarm and produced groundwater contour plots for each triennial reporting period. Contours from March 1996 and March 2003 are given in Figure 9 and Figure 10 below. Note that each of these contours is superimposed over a 2003 aerial photo of the treefarm site. These plots show that the summer 2003 groundwater levels were very similar to those in 1996, when the treefarm was very lightly irrigated.

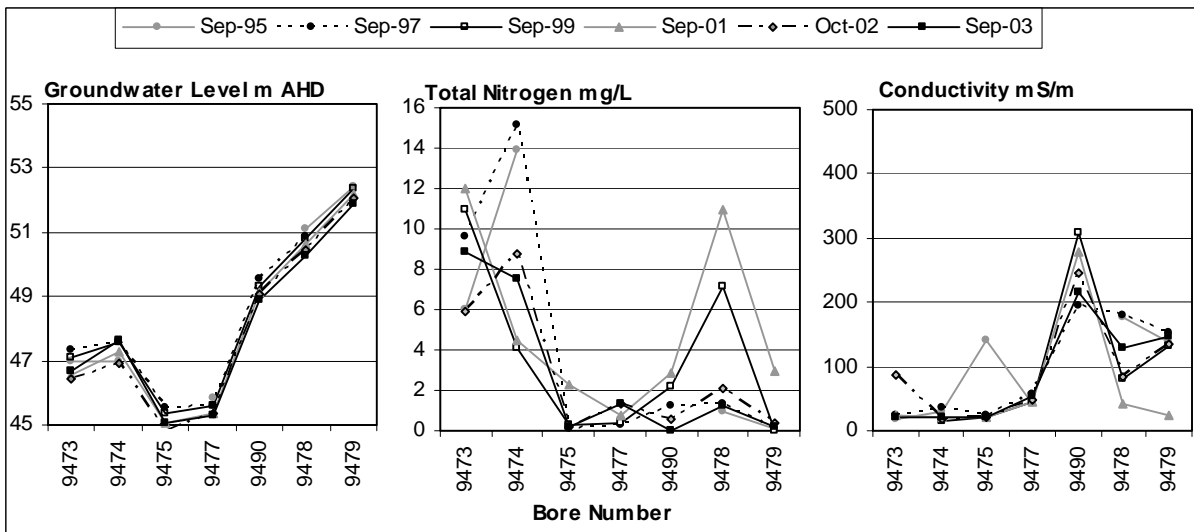
Figure 12 Cross-section of bore data along the southern boundary

Groundwater from the treefarm exits the site along the southern boundary. Figure 12 below shows variations in groundwater level, total nitrogen concentration and conductivity across the southern boundary from 1995 to 2003. There was an immediate reduction in the total nitrogen concentration

along the western end of the southern boundary at the commencement of the treefarm operations, and a more recent reduction observed at the eastern end. Groundwater levels have also reflected the establishment of plantation and also differences in annual rainfall, though groundwater level changes have been small.

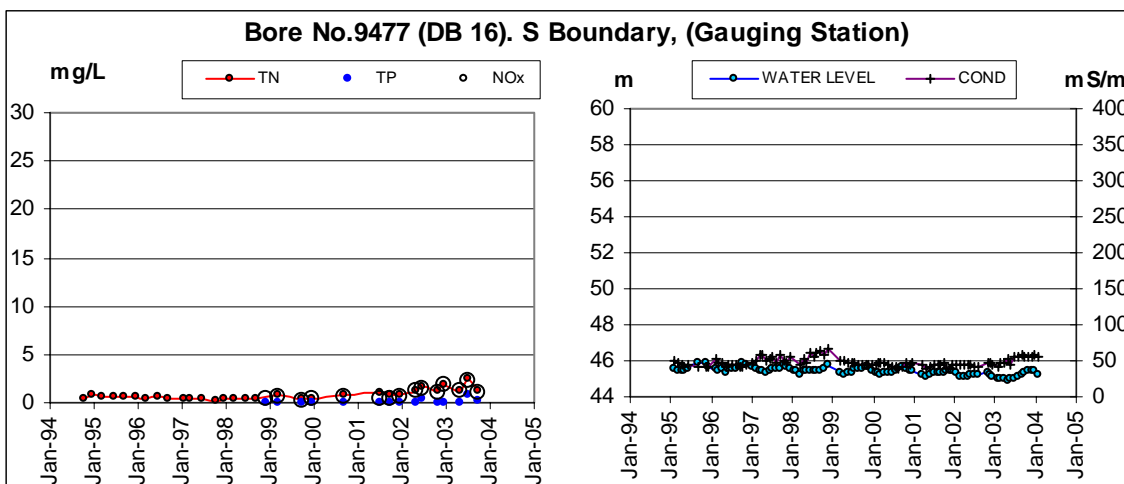
Figure 13 Bore 9474 southern boundary - nutrients, conductivity and water level.

Individual bores along the southern boundary continue to show strong seasonal fluctuations in groundwater level, particularly in the valley area where groundwater and surface water interactions are the strongest. Total nitrogen concentration varies with groundwater and season owing to the increased flows and dam level during winter. Bore 9477 (Figure 13 below) shows consistently low nutrient concentrations at the boundary adjacent to the Seven-Mile Creek gauging station. There has been a slight increase in total nitrogen (nitrate) in this bore, and this will be monitored with conductivity (which to date has been stable) to detect the presence of treated wastewater.

Comparison of rainfed (bores 9474, 9475 and 9479) and irrigated (9473, 9478, 9490) bore data shows nitrate levels below the rainfed areas to be consistently lower than the irrigated areas. This is consistent with the irrigation of treated wastewater and the nutrient management purposes of the rainfed trees, particularly in the valley area. Bore 9479 located at the south-eastern border of the site on farmland shows background groundwater conditions, and irrigated areas on the southern boundary are comparable to this site.

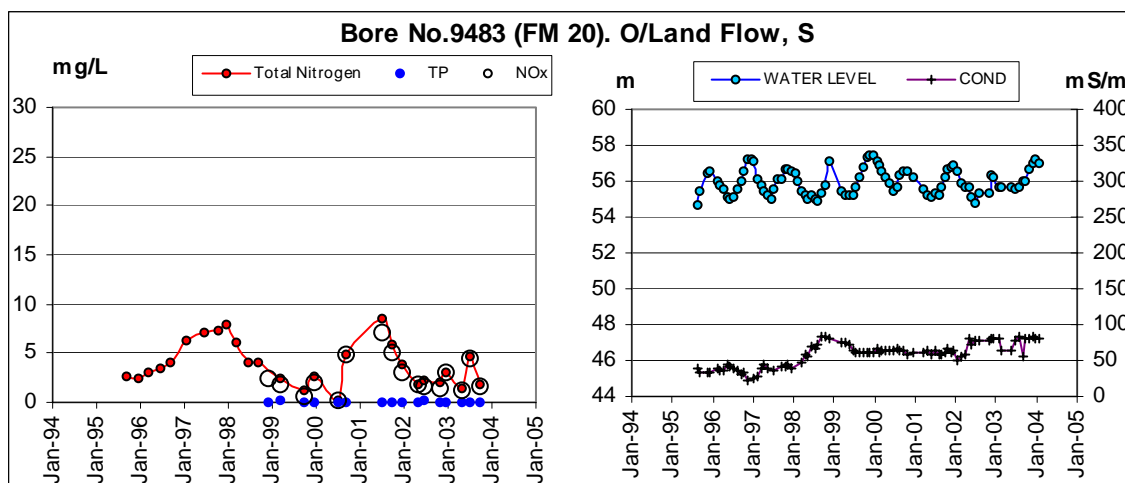
Figure 14 Bore 9483 overland flow area - nutrients, conductivity and water level.

The four bores in the over land flow area show high seasonal change in level due to the high irrigation rates and seasonal rainfall. In the last Triennial report published in 2001, it was reported that the groundwater level in this area had stabilised at one metre above the historic levels as a result of the irrigation. The more recent data shows that the groundwater level has fallen back to levels comparable to when the treefarm was established. This has been attributed to the drier winters experienced in 2001 and 2002.

Bores 9483 (Figure 14) and 9484 are at the lower edge of the overland flow bays and show seasonal changes in level as well as typical variations in nitrogen. The increases in nitrate concentration below the grass bays was expected at design, and is a function of the higher nitrogen loading that has occurred in recent years.

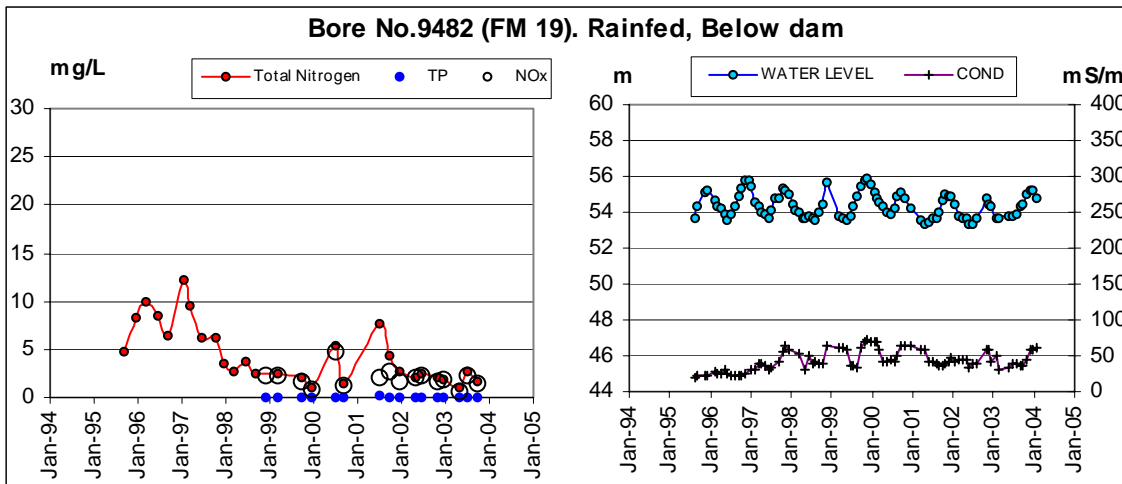
Figure 15 Bore 9482 rainfed below dam - nutrients, conductivity and water level.

Bores below and adjacent to the storage dam typically show a seasonal variation in level due to the changes in the dam storage. Bore 9482 (Figure 15 below) in rain-fed trees immediately below the dam wall, shows the largest response to the hydraulic pressures at the dam wall. The conductivity of 20-70 mS/m is representative of the groundwater at the site before the treefarm was established. The total nitrogen concentration has fallen since 1998 as a direct result of repair to the dam lining in March 1998. The total nitrogen concentration has fallen because there is less transient flow through the bore site and this additionally allows greater transformation of nitrogen in the soil.

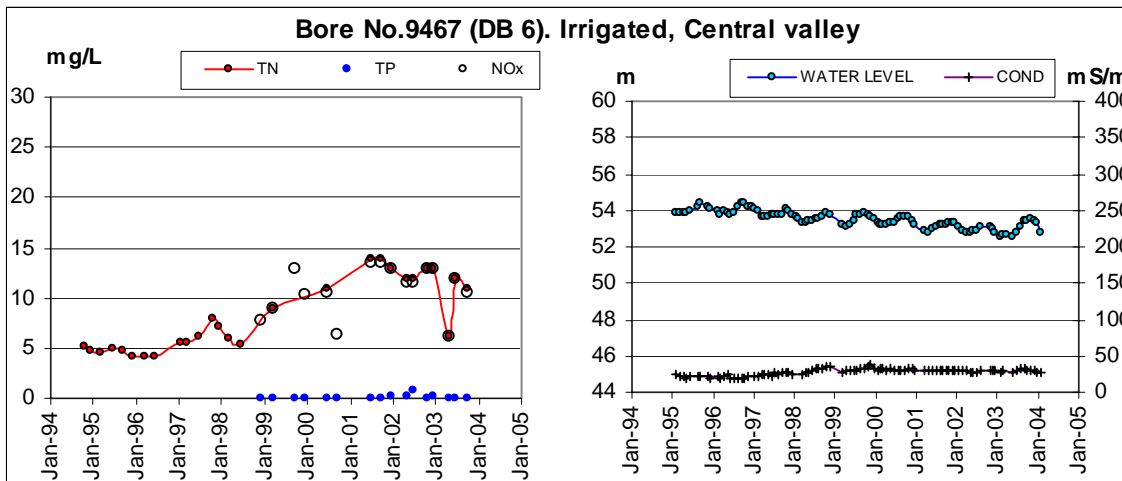
Figure 16 Bore 9467 irrigated, central valley - nutrients, conductivity and water level.

Bores 9450, 9467, 9471 and 9481 are all located at the centre area of the treefarm and above the valley. Total nitrogen in these bores is consistently low except for bore 9467 (Figure 16 below). This bore is located at the junction of three access roads and is in a depression in the surface topography. There has been no significant increase in conductivity, and groundwater has declined steadily since the commencement of irrigation activity at the site. Given that the conductivity has remained constant in this bore, it is unclear why the nitrogen concentration should be increasing. This area becomes very wet during winter and especially following storm rainfall events, so it is possible the nitrate concentrations of greater than 10mg/L may be attributed to excessive flushing of the irrigated soils. This would have to be through the drainage accumulation of rainfall as the conductivity results suggest the flushing is not caused by irrigation of treated wastewater.
