# Water Efficiency Audit

Office Block

December 2010

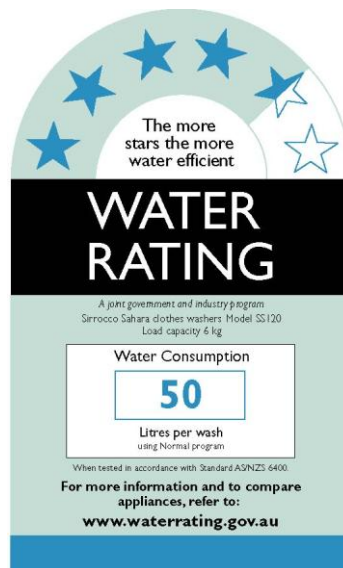
WELS Rated appliances and devices will carry this label.

Additional Information on WELS Rated products can be found at [www.waterrating.gov.au](http://www.waterrating.gov.au) and at **Appendix 2** of this report.

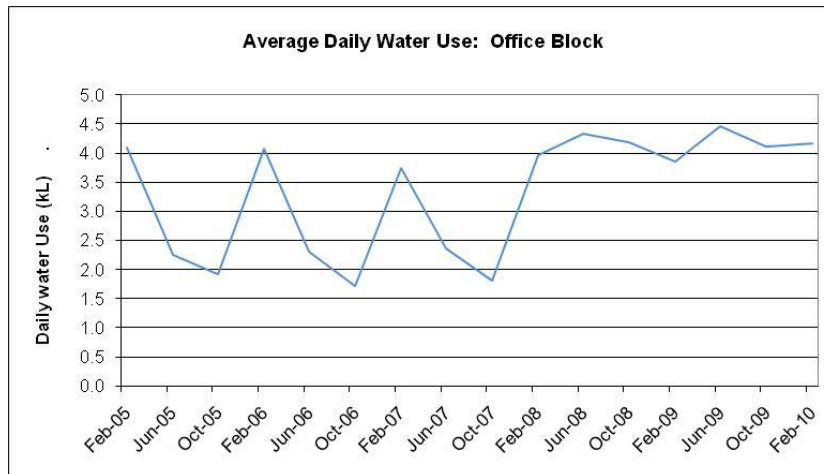
FIGURE 1: Average Daily Water Use, Office Block.

As Figure 1 shows, there is a cyclical pattern with summer peaks in water use, and winter troughs. This pattern of water use is usually driven by climate dependent uses such as irrigation and/or evaporative air conditioners. The pattern has been disrupted in recent years and the audit revealed that the appropriate winter settings for the irrigation system have not been applied in recent years.

Figure 2 shows the metered water use at the Office Block. Water meter data has been converted back to average daily water use.

The average water use over past years has varied significantly and an average is difficult to calculate. It is **recommended** that managers record the water use in kL over the next 12 months and use this as a benchmark against which future water use is measured. It is **recommended** that any significant increase in water use (more than +/-15%) be cause for investigation by site managers.

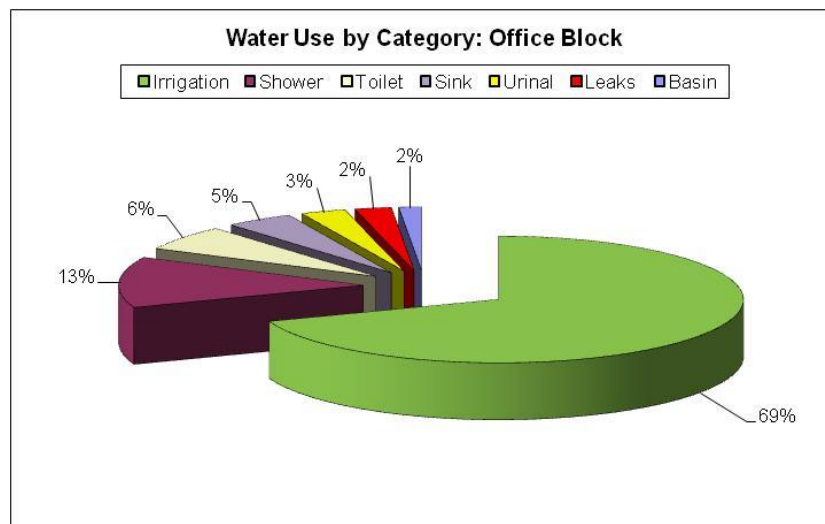
FIGURE 2: Modeled annual water use by category, Office Block.

Water use	Demand (kL/a)	Percentage
Irrigation	1,008	69
Shower	188	13
Toilet	93	6
Sink	65	4
Urinal	43	3
Leaks	35	2
Basin	22	1
<b>TOTAL</b>	<b>1,454</b>	<b>100</b>

TABLE 1: Modeled annual water use by category, Office Block.

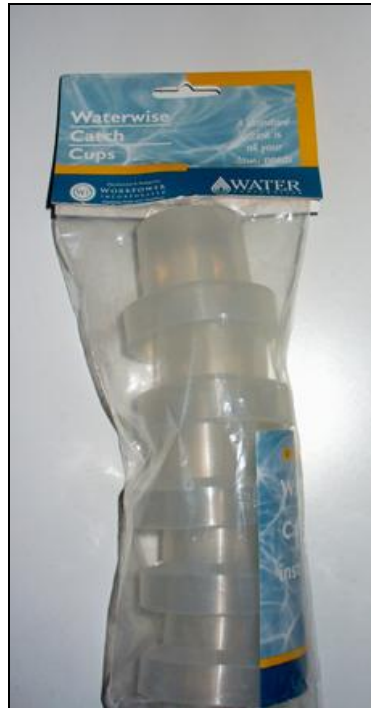
FIGURE 3: Irrigation catch cups.

Irrigation catch cups which can be placed on lawns and gardens watered by sprinklers to determine the relationship between your irrigation run time and the depth of water it delivers. By using these catch cups, one can adjust the irrigation station run times to ensure water is being used as efficiently as possible.

It is strongly **recommended** that these catch cups be used to establish the run time per station to deliver the “standard drink” for your area.

It is strongly **recommended** that these catch cups be used to establish the run time per station to deliver the “standard drink” for your local conditions.
